# SAFETY RECALL

October 2011

A small number of 2012 Trek bicycles were made with a saddle clamp bolt, on the seat post, that exhibits hydrogen embrittlement. This is a list of the affected models:

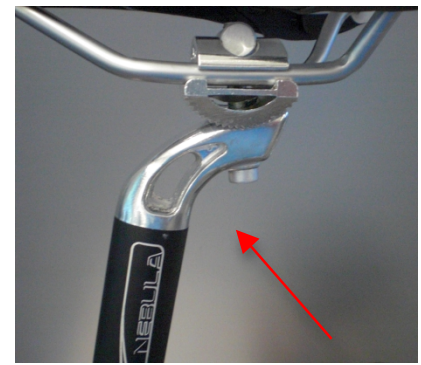
Hydrogen embrittlement could allow the saddle clamp bolt to break, which could allow the saddle to come off the seat post unexpectedly. If this happens, the rider could fall and possibly be injured. Your safety is very important to us. Therefore, Trek will replace the saddle clamp bolt on an affected bicycle, free of charge.

Figure 1. Nebula seatpost showing saddle clamp bolt

If you own a bicycle that is affected by this recall, Trek will provide you—through your Trek dealer—a free replacement of the saddle clamp bolt on your bicycle. If you have any questions, please contact your dealer, or call Trek at the special recall hotline:
